CALSPAN ON-SITE AIR BAG DEPLOYMENT INVESTIGATION
CALSPAN CASE NO. 92-12
VEHICLE - POLICE 1991 FORD LTD CROWN VICTORIA
LOCATION - [REDACTED] CA
ACCIDENT DATE - [REDACTED] 1992

14. Sponsoring Agency Code	
15. Supplementary Notes On-site investigation of a single vehicle roadside departure crash that involved a police 1991 Ford LTD Crown Victoria. The driver sustained a minor (AIS-1) burn of the left fingers from contact with the inflation module.

17. Key Words Roadside departure crash Right side impacts Air bag deployment Inflator temperatures of 300°C (578°F) Thermal burns of driver's left hand, AIS-1		18. Distribution Statement General Public

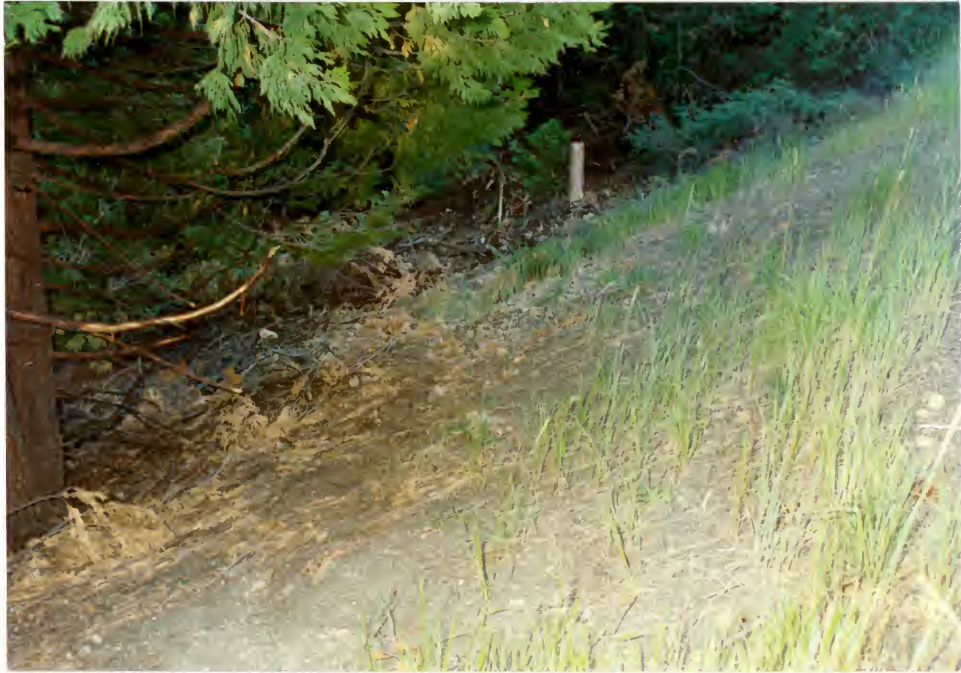
Due to the slope of the embankment, the broadside trajectory of the vehicle, and vehicle contact with the ground, the Crown Victoria began to pitch to its right. The upper surface of the right front fender impacted a 20.3cm (8") diameter cedar tree that was located 9.1m (30') outboard of the roadedge. The tree impact damage began on the fender at bumper level and extended vertically onto the top of the fender and hood, indicating a non-horizontal (00-LFMN-3)) impact force. Direct contact damage began 40.6cm (16") forward of the axle position and extended 20.3cm (8") forward to the leading edge of the fender. The vehicle subsequently impacted a small diameter tree with the right front fender area. The damage was located 16.5-30.5cm (6.5-12") forward of the referenced axle position and involved 7.6cm (3") of crush on the lip of the wheel opening. The

impacts fractured the 20.3cm (8") diameter tree 81.3cm (32") above ground level and displaced the stump to the east as the vehicle overrode the remaining trunk of the tree. The small diameter tree was completely uprooted and displaced from its location on the embankment.

Struck Tree Branches
And 20.3cm (8") and 25.4cm (10") Diameter Cedar Trees.

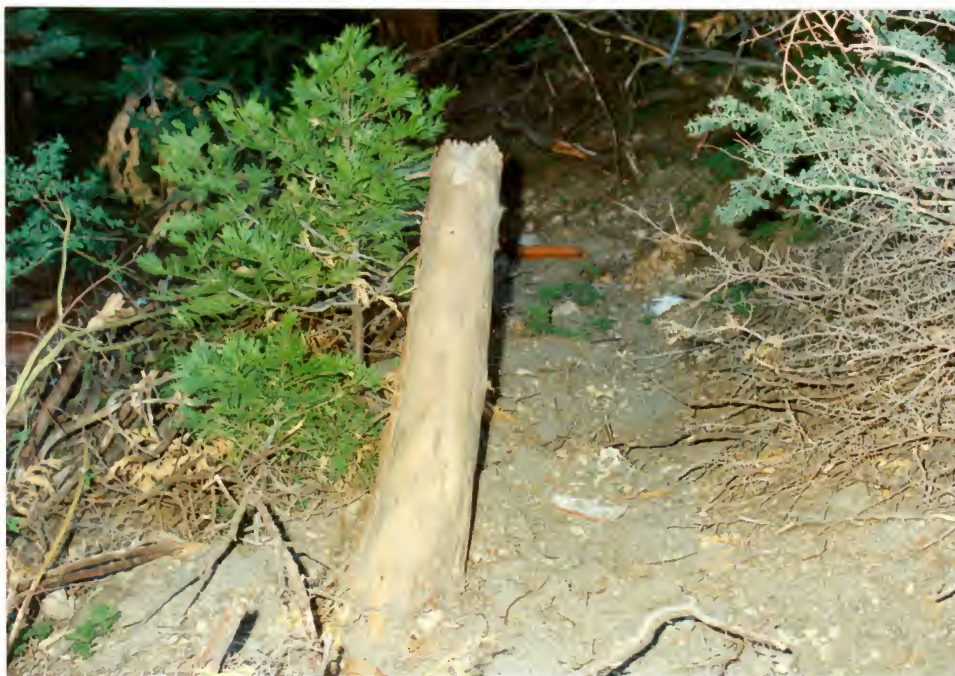
The Crown Victoria continued to pitch to its right and subsequently impacted a 25.4cm (10") diameter cedar tree that was located 2.4m (8') east of the previously struck 8" diameter tree. The impact damage extended vertically from the sill of the vehicle onto the side rail and roof. Due to the slope of the embankment and the vehicle's attitude at impact, the damage was diagonally orientated on the right passenger compartment area. Direct contact damage on the right front door and sill area began 111.8cm (44") rearward of the right front axle and extended 35.6cm (14") rearward. The direct contact damage on the right roof side rail began 162.6cm (64") rearward of the axle position and extended 33cm (13") rearward. Maximum crush was 83.8cm (33") located on the right roof side rail at the B-pillar. Crush values at the side rail level were as follows:

Final Impact Sequence Against The 25.4cm (10") Diameter Tree.

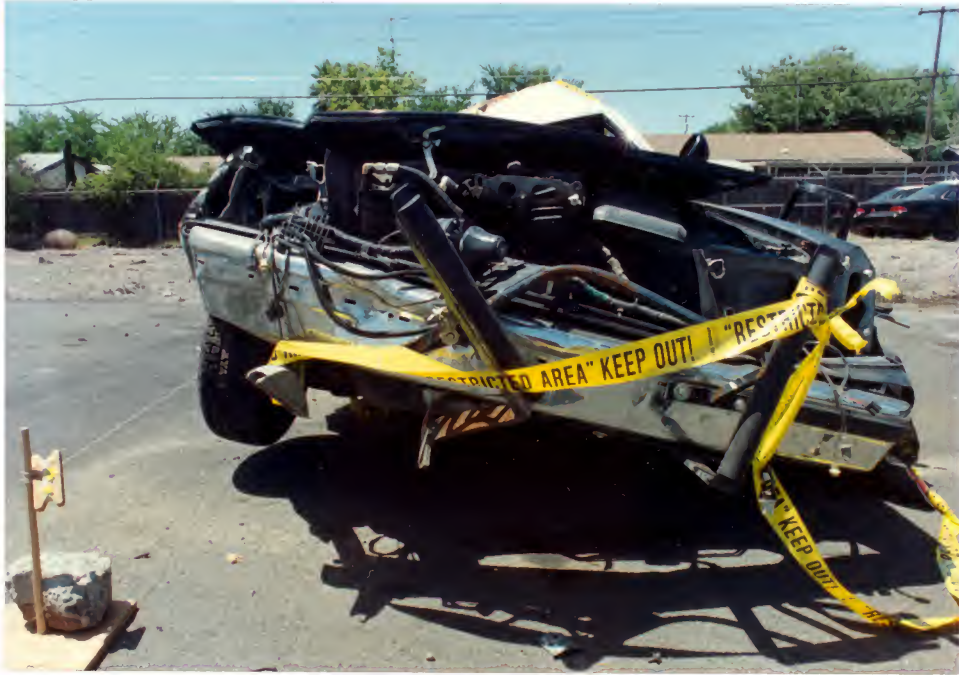
The exterior of the 1991 Ford Crown Victoria sustained severe damage from multiple impacts with roadside and off-road objects. As the vehicle exited a left curve, it drifted onto the right shoulder and impacted a delineator with the right rear quarter panel area. The impact produced 12.7cm (5") of crush to the panel that was located 86.4cm (34") rearward of the right rear axle. The deformation to the quarter panel began 15.3cm (6") rearward of the referenced axle and extended 111.8cm (44") to the rear bumper. The vehicle rotated across the travel lanes in a counterclockwise direction and departed the left roadedge in a near broadside orientation. As the vehicle departed the roadway, the right front fender area impacted and dislodged a steel delineator post from the cinder and earth shoulder. Paint abrasions were noted to the fender 20-48cm (8-19") rearward of the right front axle position and were vertically orientated on the fender above the wheel opening. Crush damage to the area was masked by subsequent impacts.

Frontal View Of The Ford Crown Victoria.

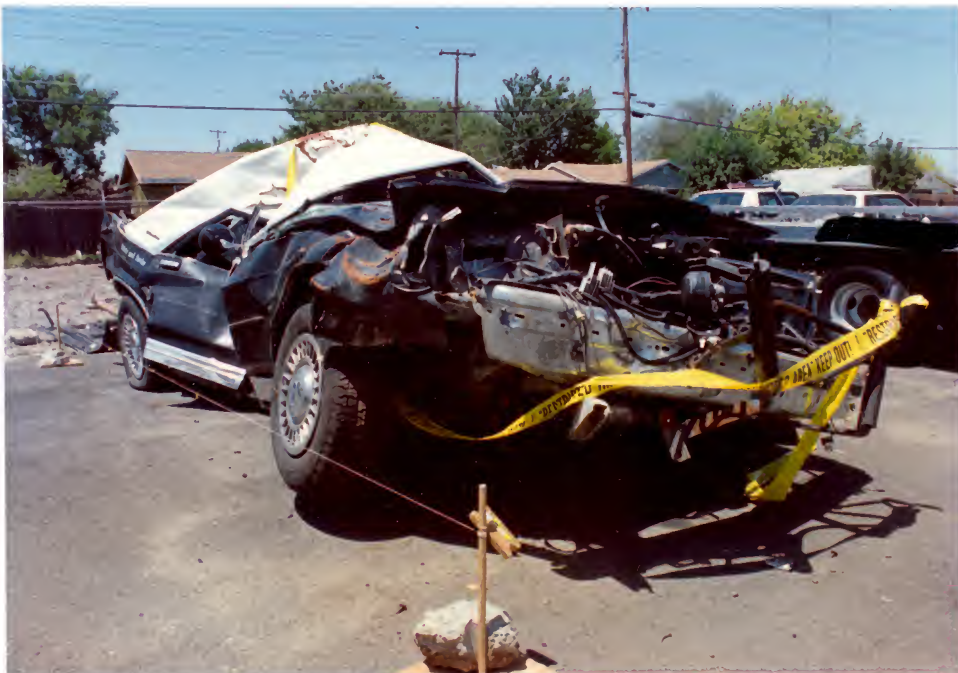
Right Front Three-Quarter View.

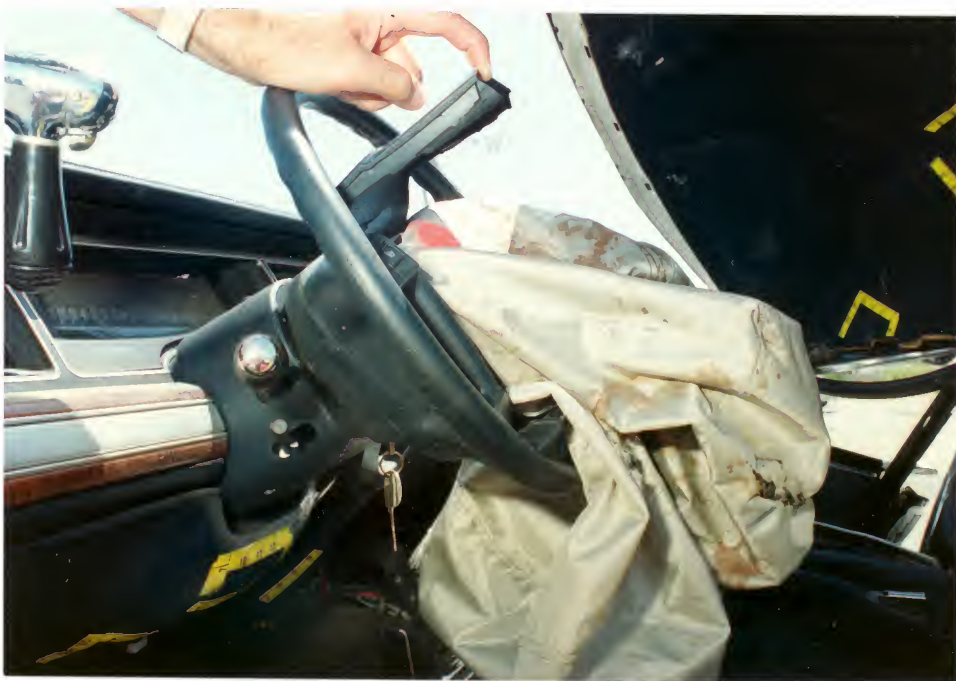
Perpendicular View Of The Module Flaps.

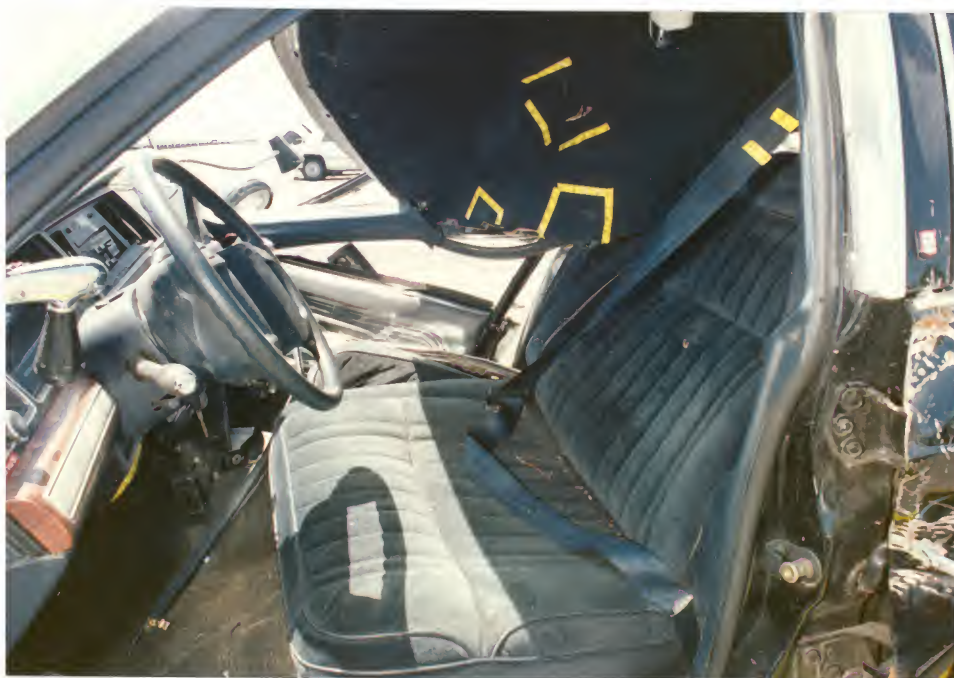
The driver of the vehicle moved laterally to the right in response to the right side tree impacts. His knees and lower legs initially contacted the fuse box cover and the knee bolster. The fuse box cover was scuffed 53-61cm (21-24") left of center and 41-46cm (16-18") below the top surface of the instrument panel. A lower leg scuff was noted to the bolster 39-46cm (15.5-18.3") left of center and 38-43cm (15-17") below the upper panel. The driver's right knee contacted the protrusion of the bolster at the base of the steering column. A scuff mark and disruption of the vinyl covering was noted 38-46cm (15-18") left of center. The lateral aspect of the driver's right knee contacted the center mid instrument panel (scuff) and the center mounted police radio equipment. Although the radios were removed prior to our inspection of the vehicle, a deformed bracket was found in the vehicle, indicating contact to the components.

The driver's head and facial areas impacted the intruding vertical surface of the roof. The 11.4cm (4.5") diameter contact cracked the backer panel to the headliner and bowed the roof panel outward .6cm (.25"). The contact point was located 38-51cm (15-20") rearward of the A-pillar and 22-34cm (8.8-13.3") above the roof side rail. His right forearm impacted the right siderail 20-29cm (8-11.5") rearward of the A-pillar, depositing tissue transfers on the fabric covering. The driver's thoracic area contacted the B-pillar; however, no

Driver's Trajectory And Contact Points.

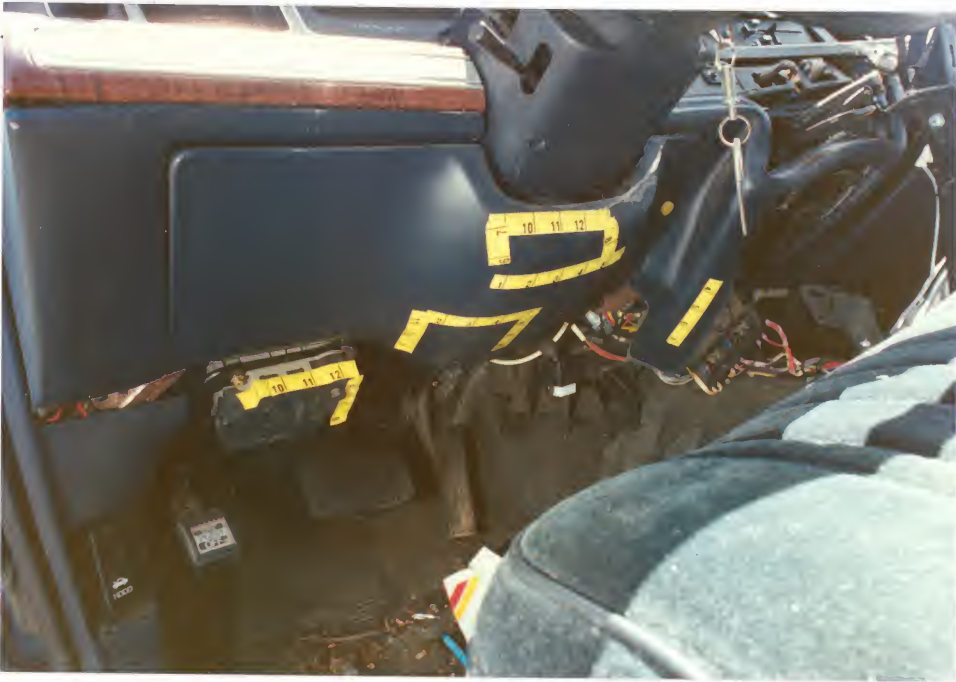
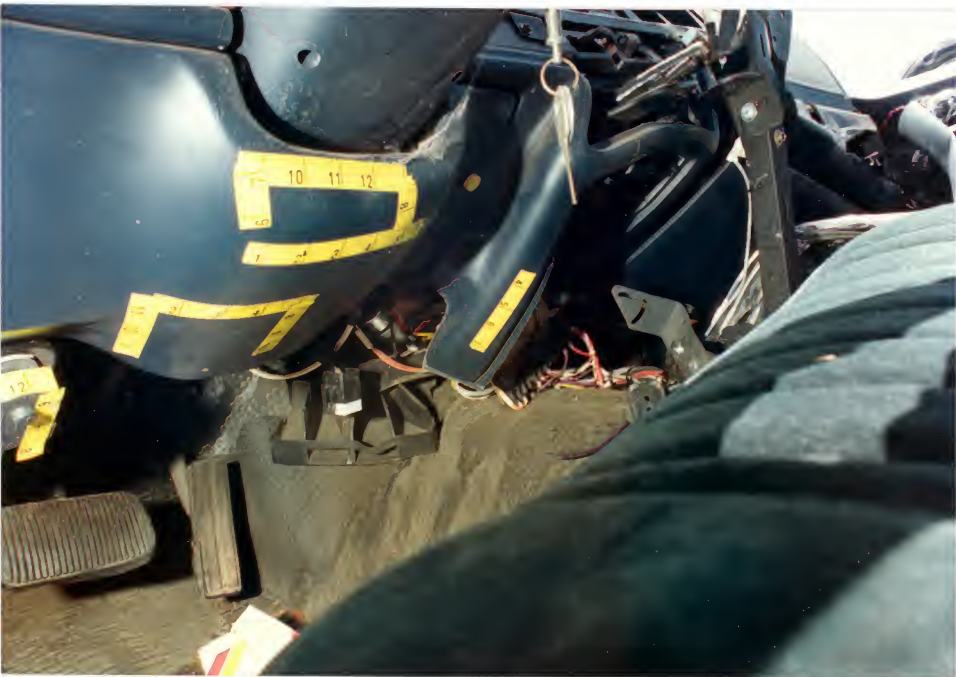
Knee And Lower Leg Contact Points
To The Knee Bolster And The Lower Panel

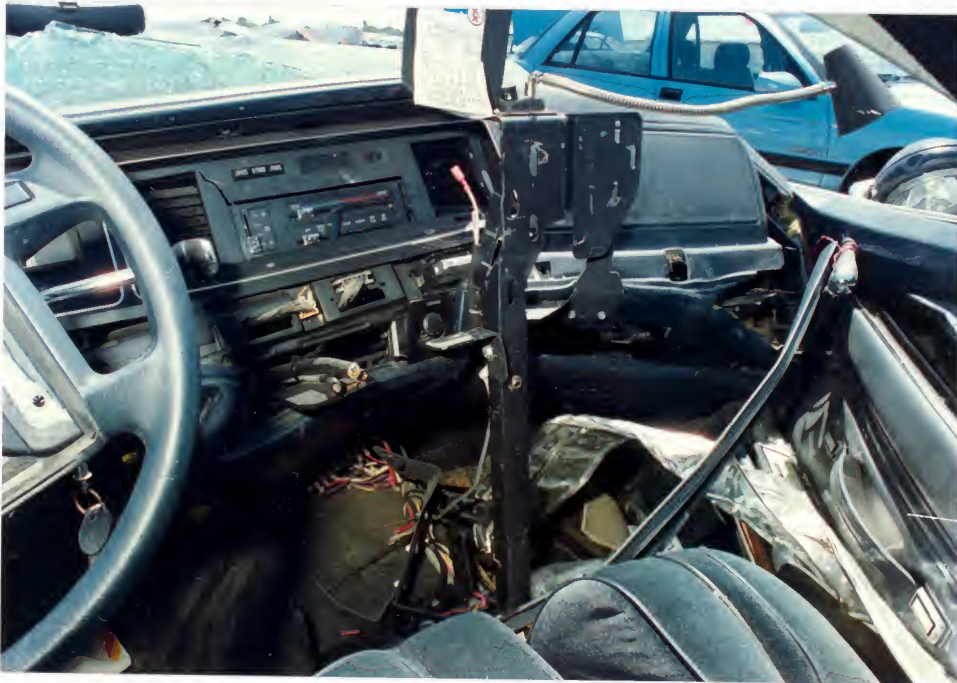
Probable Right Leg Contact To The
Center Mounted Radio Equipment (Removed) .

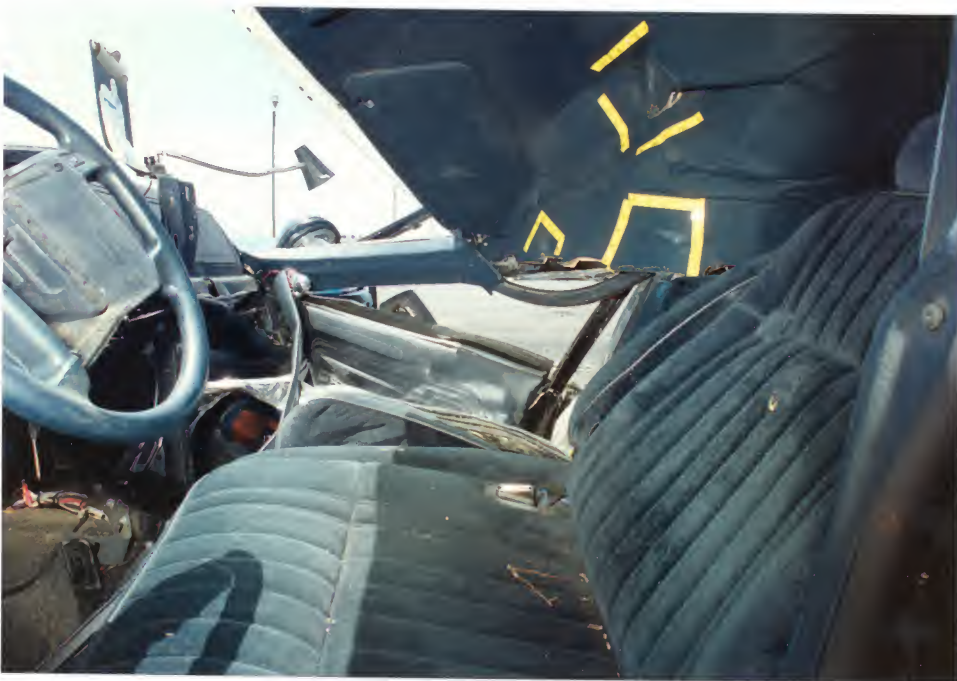
Right clavicle fracture	Moderate (SRFS-2)	Intruding right roof side rail

Head, Arm, And Shoulder Contact Points
To The Intruding Roof And Side Rail.

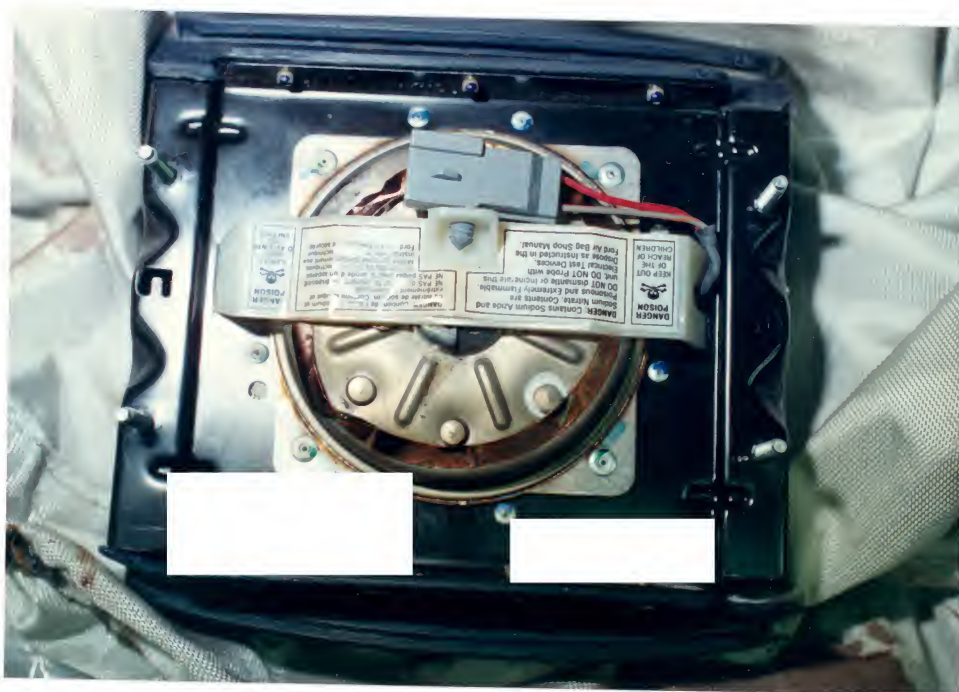
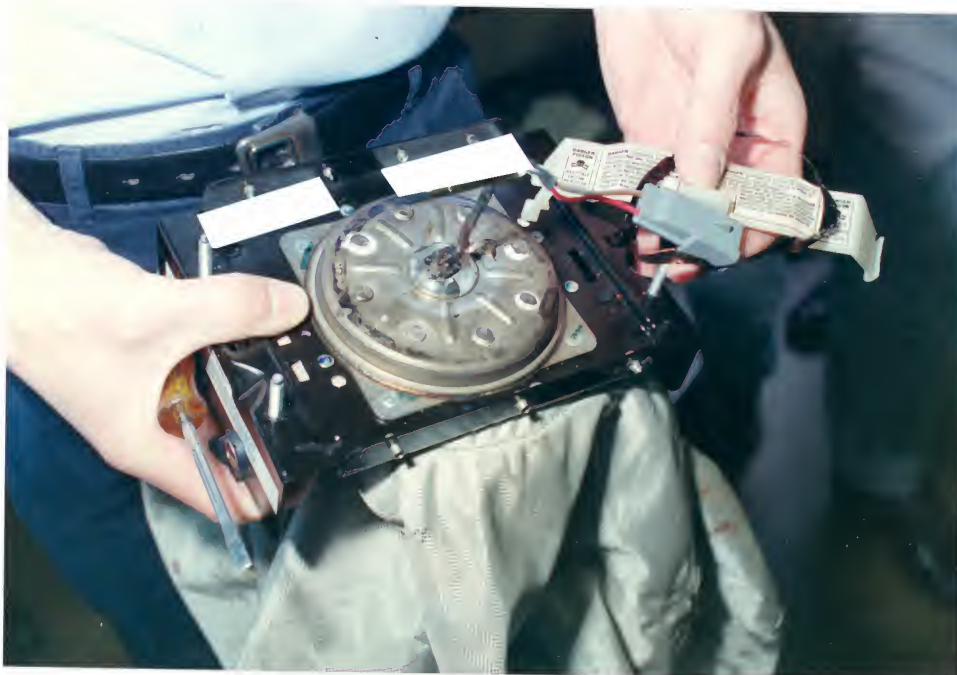
Backside Of The Removed Module Assembly.

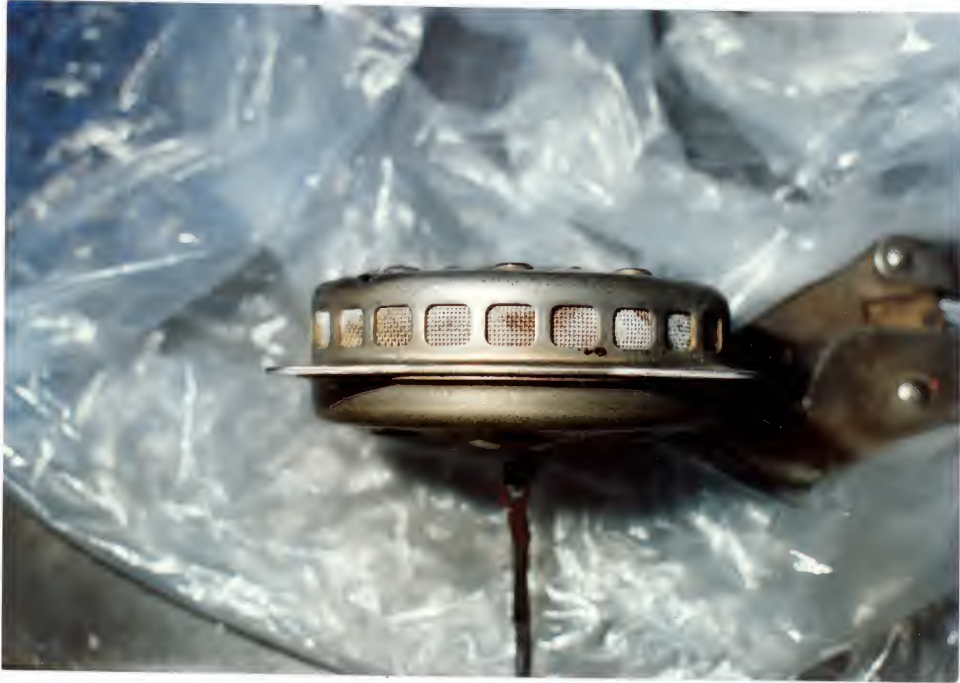
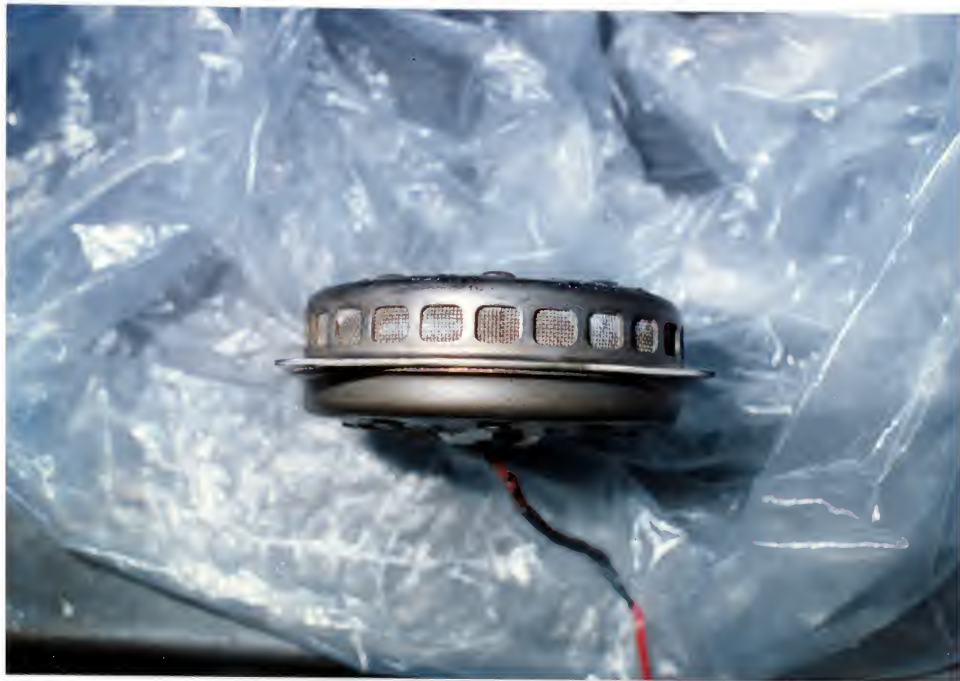
possible defects. Numerous members of the [REDACTED] Highway Patrol were also present. The TRW representative thoroughly discussed the deployment process of the module and used several models to identify the internal components. During his discussion, he stated that the air bag fabric had a melting point of 154-177° C (310-350° F) and that the nylon/neoprene material would not support a flame. The inflator housing and its internal filtering screens were manufactured from stainless steel. The TRW representative stated that the inflator module reaches deployment temperatures of 300° C (578° F) and cools slowly due to its isolated, non-vented location within the steering assembly.

Additional Views Of The Radial Inflation Ports.
